# Landslide Challenges Due to Widening of Road Section Between Udhampur and Chenani Along National Highway-44, Jammu and Kashmir, India

*Widening of 295 km National Highway-44 in Jammu and Kashmir is an important developmental project. The highway passes through Outer Himalayan and Higher Himalayan sequences of rocks and is frequently affected by landslides at various places. The paper deals with 22 km Udhampur-Chenani section of the highway within the Siwalik sedimentary sequence. The area is prone to landslides on account of fragile geological, topographic and hydrological conditions. The study area has high rainfall intensity and numerous old landslides zones. At the project feasibility stage, project authority has identified the landslide-prone area and suggested precautionary measures but during the construction work, various unpredicted landslide and ground sinking events happened which given trouble in road construction cost and project completion time. In this paper, the challenges faced due to landslide and ground failure as failure of old slide adjutant to road construction, agriculture and residential ground failure at a higher altitude due to road construction, the col

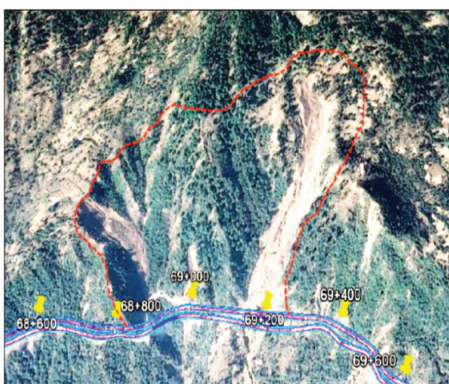
Map 2: Google Earth Image of Bali Slide

- Bali Landslide zone: Bali landslide zone is made up of colluvium material with 12-18 per cent water content, 25-41 per cent liquid limit, 17-20 per cent plastic limit,

having Silty sand (SM) in nature. These sliding activated during the monsoon, due to liquefaction. In this section minor bridge was proposed to avoid the landslide disturbance. GECPL has permanently deputed the machineries for 3-4 months during monsoon season. Google earth image (Map 2) shows steep topography and colluvium materials in this landslide zone.

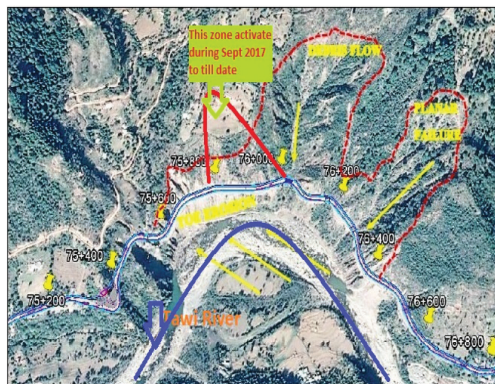
Map 3: Google Earth Image of Samroli Slide

- Samroli Landslide zone: This slide is in between Ch. 75 + 600 km and Ch. 76 + 400, differential and aggressive erosion of the Mudstone/shale layer in between the Sandstone layers. Soil properties are the same as the Bali landslide zone. Anticline and Syncline geological feature are well developed in between the Sandstones and Mudstone layer. The crested part of this syncline is dislocated along right limb by a dip-slip fault and along left limb by a tear fault. The Sandstone bands are fractured and blocky in nature and due to the joint orientation, a series of triangular troughs of erosion have been created in the weaker rock. During the rainy season the strata is water charged and lubricated along the joint planes and wedge failure and toe erosion beneath the Sandstone band; shown Samroli slide (Map 3).

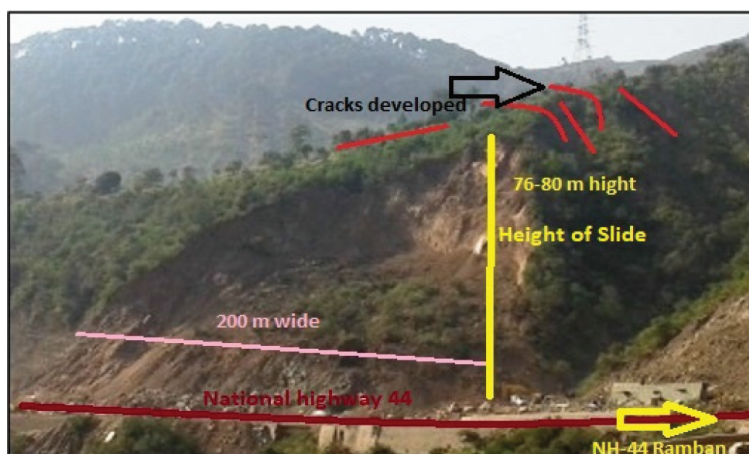
The bridge abutment in this location was constructed in the month of August 2017 but in the same year in the month of September, sliding started and completely blocked the NH -44 for one week. The bridge was also covered with sliding mass, about 200 m long and 70-80m high. More cracks were observed about 60-70 m away from the top of the slide area (Photo 1). The cracks width was 20-30 cm, 50-60 m long and depth up to 4-5 m and beyond (Photos 2 and 3). Cracks were developed in two high tension electricity tower foundation and agriculture land at the top of the landslide. Minor bridge abutment was cracked and settled due to this slide, which completely blocked

**Photo 1: Samroli Landslide with dimension and cracks marked, during Sept 2017 event.**

the NH-44 for single lane also (Photo 4). The Cracks were filled with Kanker, Sand, Cementaggregate. Drainage was also provided to avoid the surface water percolation inside the cracks.

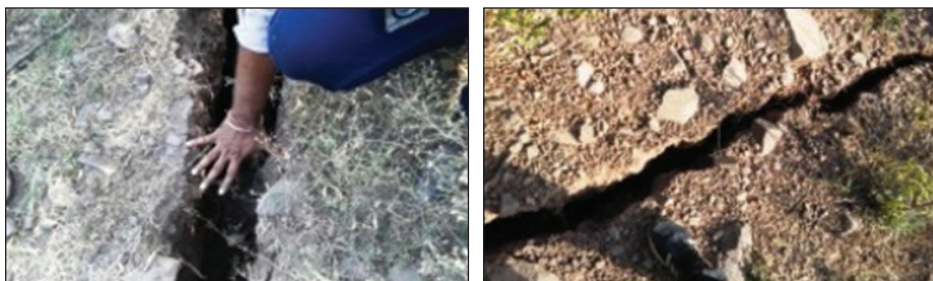
**Photo 2 and 3: Cracks developed at top of Samroli Slide during September 2017 event.**

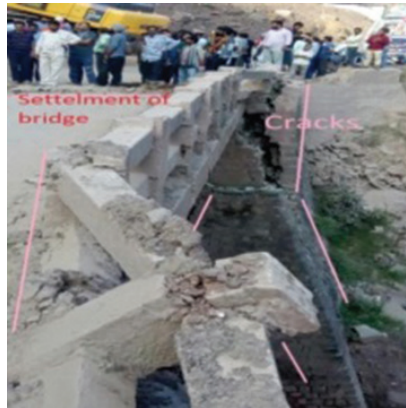
**Photo 4: Settlement of bridge and Cracks in bridge abutment A2.**

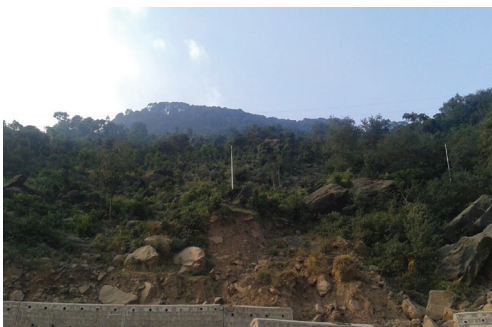
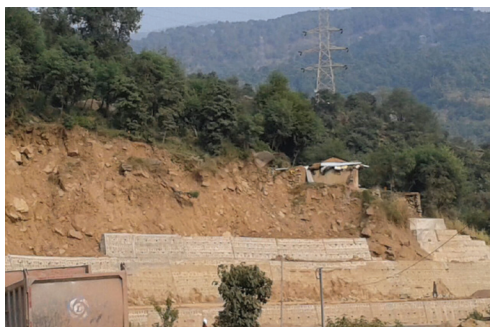
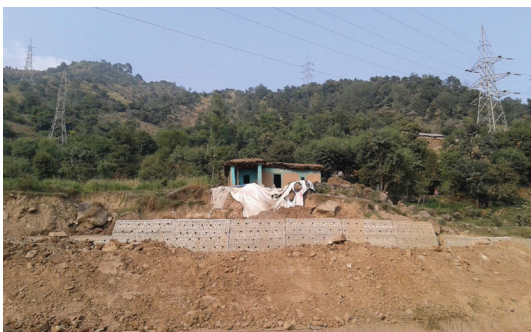
- **Bali Village:** Maximum numbers of houses damage were reported in this area. Geologically the area is made up of thick colluvium materials- Silty soil with big boulders, slope are gentle with the medium cover of vegetation. Google Earth image is showing that areas forming spoon shape (Landslide prone area) due to hydrological and man-made activities in this area. Rock present at a deep level and slope angle are also high. Geomorphological, hydrological and geologically area have landslide favorable zone and old landslide zone. Presence of water, good agricultural soil had attracted humans for settlement in this area. Strength of colluvium materials would be very less and due to water percolation in subsurface lubrication form at contact plane of rock and colluvium, the landslide has been started at a huge level as shown in Photos 5-7.

**Photo 5: Geological strata from Ch 70 + 600 km to 71 + 200 km, Bali Village**

**Photo 6: Geological strata from Ch 70 + 600 km to 71 + 200 km, Bali Village**

**Photo 7: Geological strata from Ch 73 + 400 km to 73 + 600 km, Bali Village**

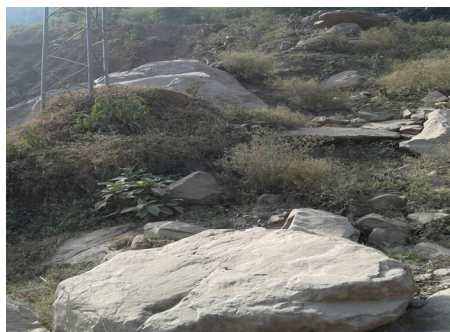
- **Toldi Village:** Only one number of house damage was reported in this area. House is very near the ROW of the project. Geologically the area is made of thin colluvium materials 3-4 m before the Siltstone interbedded with sandstone rock, dipping gentle towards valley side, refer Photo 8.

**Photo 8: Geological strata at Ch 78 + 500 km, Toldi Village**

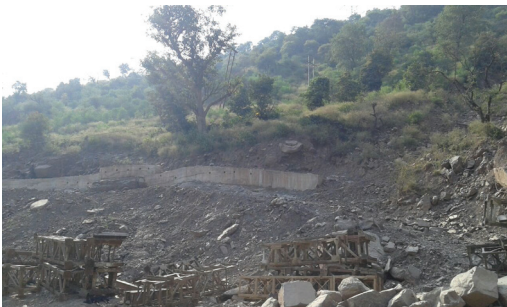
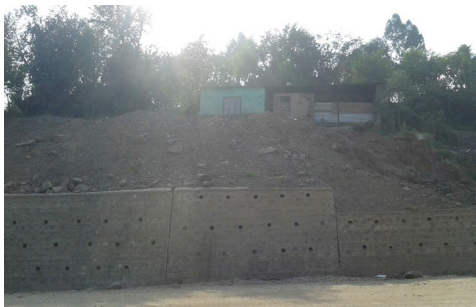
- **Narsoo Village:** Three number of house damage complains were reported in this area. Houses are about 150 m far from the ROW provided to GECPL. Geologically the area is made of thick colluvium materials (3-4 m) and Siltstone interbedded with sandstone rock, dipping gentle towards valley side. Rock present at shallow depth and slope angle is high with valley side and increasing the probability of landslide refer in Photos 9-10.

**Photo 9: Geological strata at Ch 81 km, Narsoo village**

**Photo 10: Geological strata at Ch 82 km, Narsoo Village**

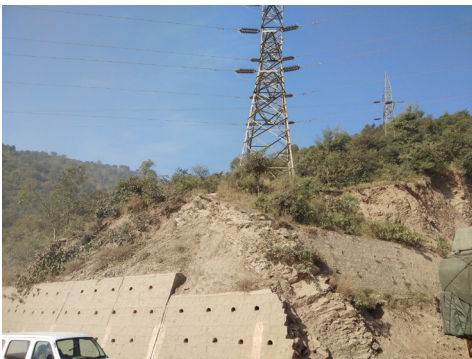
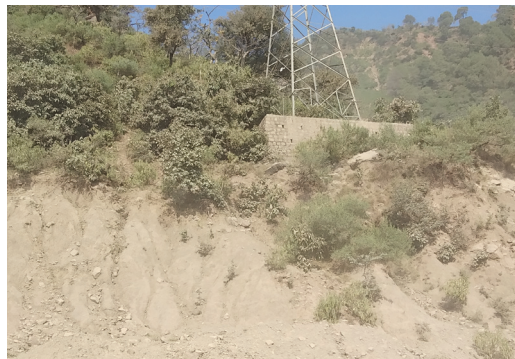
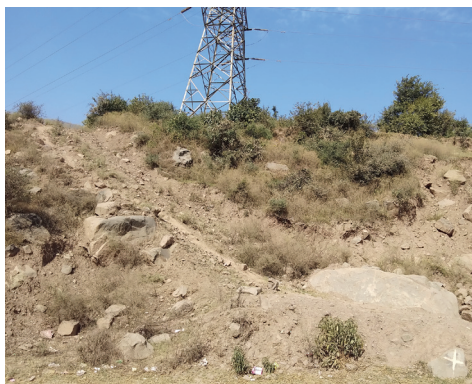
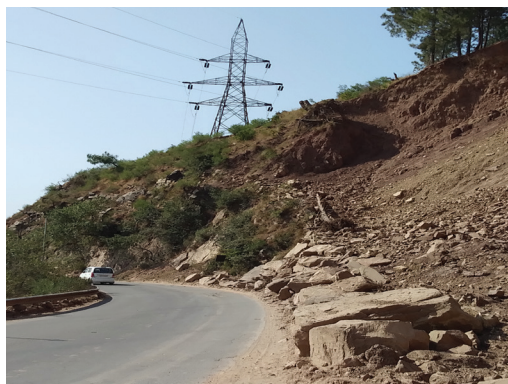
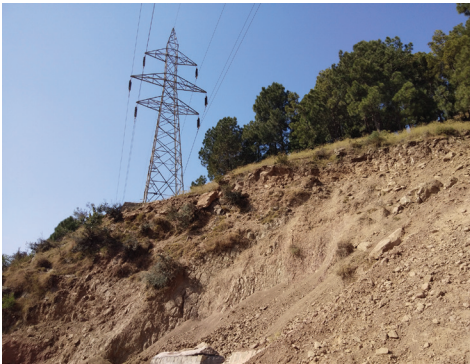
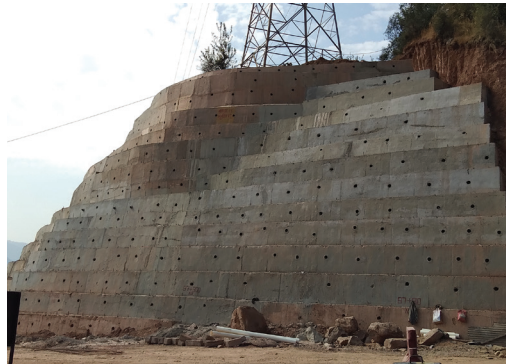
High tension electricity tower at Ch 71 + 300 km passing near the ROW were suddenly collapsed in the afternoon (60 m away from ROW) due to ground sinking at Bali slide zone. Study based on geological strata and slope failure prediction and importance of issues identified 28 numbers of towers in critical condition in which 26 numbers were suggested to be protected by micro piles, rock anchors and cladding wall as per site condition and 2 towers suggested shifting. Another tower (32.70 m from ROW) at same chainage was also collapsed within one month of collapsing of the first tower. Some tower photographs are given below (Photos 11-16):

For the protection of High tension tower nearby the ROW land, retaining wall with a drainage hole and for tower having considerable distance from project boundary and protected through micro pilling and rock anchor.
