MANIPUR EARTHQUAKE-2016 RELIEF TO RECOVERY

National Institute of Disaster Management (Ministry of Home Affairs, Government of India)

2022

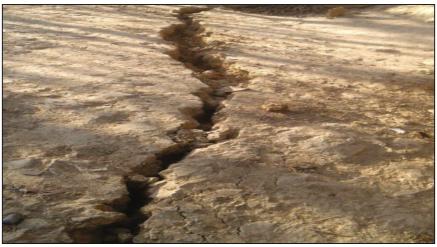
Figure 15: - Showing major cracks developed in Kabui Khullen village in Tamenglong district

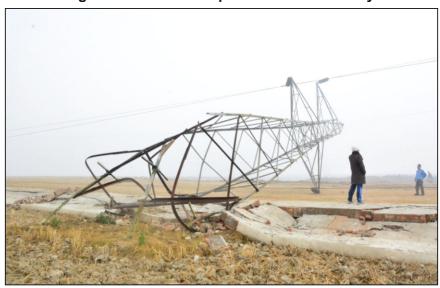
Figure 17: - Failure of power line near Noney.

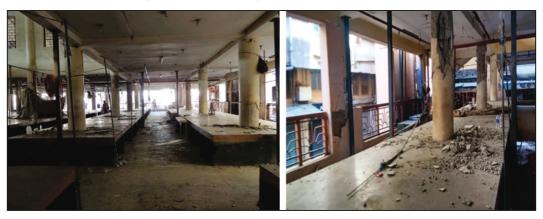
Figure 18: - Damaged Imphal Ima Market

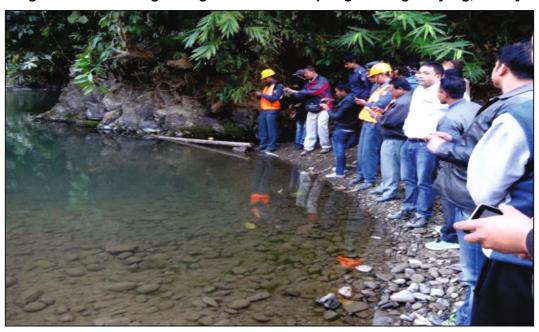
Figure 19: - Showing emergence of a new spring in Lungkhuijang, Noney

A new spring also emerged in the hill slope of Noney as shown in Figure 19 above. The location of the new spring lies in dried-up drainage. The spring emerged in a landslide portion of the drainage at an elevation of 840m.

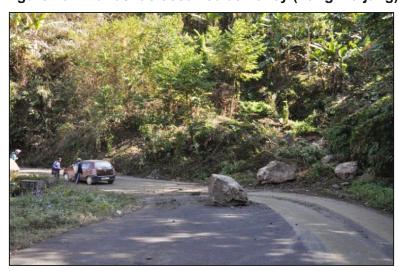
Figure 20: - Landslide occurred at Noney (Lungkhuijang)

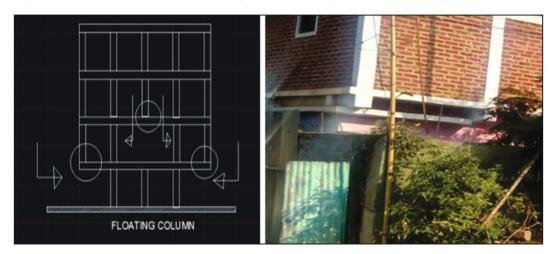
Figure 21: - A residential building with floating column at Singjamei, Imphal.

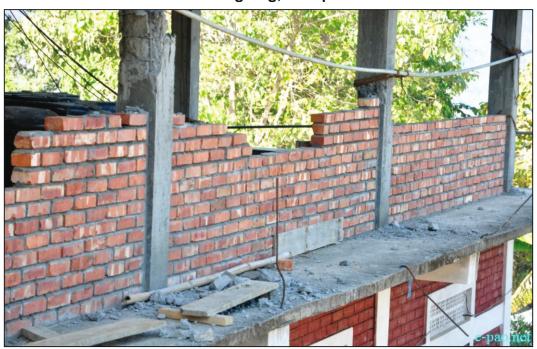
Figure 23: - Short column effect due to presence of partial infill walls at Tamenglong, Manipur.

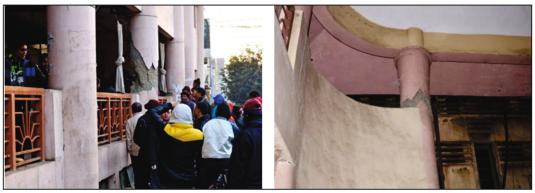
Figure 24: - Column damages due to short column effect in Imphal.

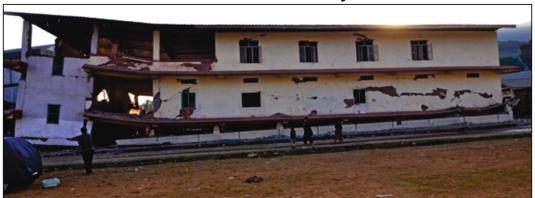
Figure 25: - Collapse of first storey of building at Saikul bazaar in sadar hills due to soft storey.

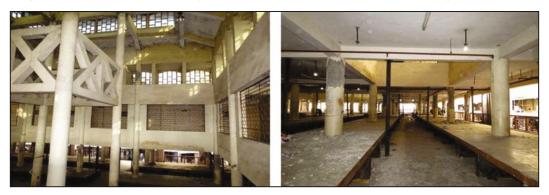
Figure 26: - Soft first storey in Laxmi Market and severe damage to column

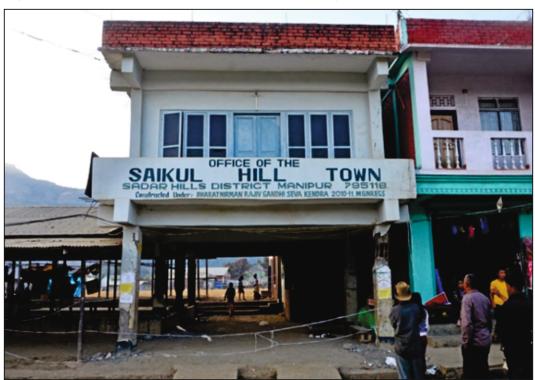
Figure 27: - Failure of columns due to soft storey in Saikul bazar, Sadar hills.

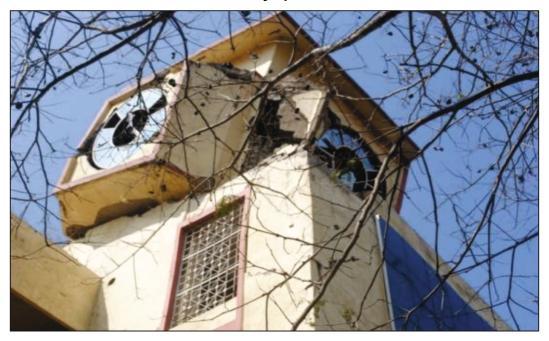
Figure 28: - Damaged building due to mass irregularity at Govt. Polytechnic, Takyelpat.

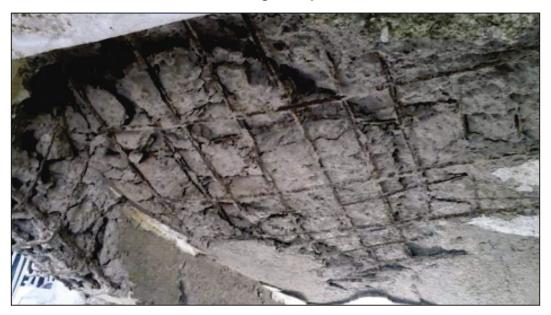
Figure 29: - Corroded reinforcement in slab, beam at Government Polytechnic building, Manipur.

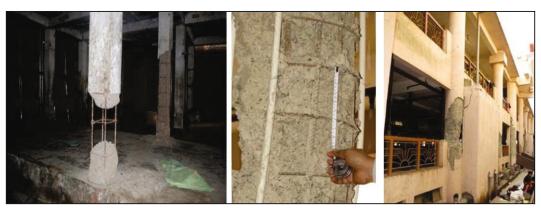
Figure 30: - Base of first storey column with widely spaced ties and spalled concrete, (Bishnupur Market.) and new market

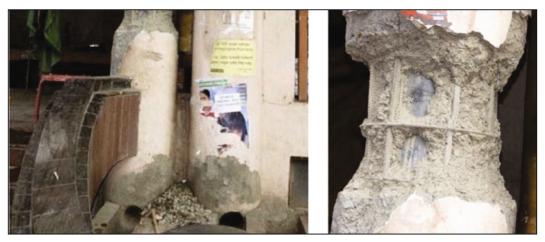
Figure 31: - Concealed drain water pipes inside the exterior columns

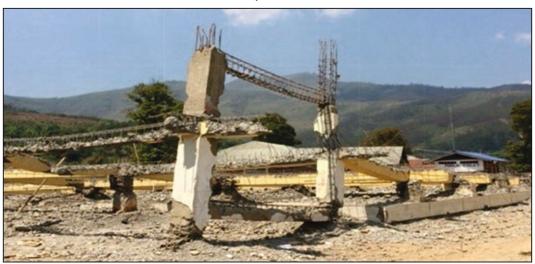
Figure 32: - Collapsed frame of a soft-storeyed RCC structure (women vendor's market) in Saikul.

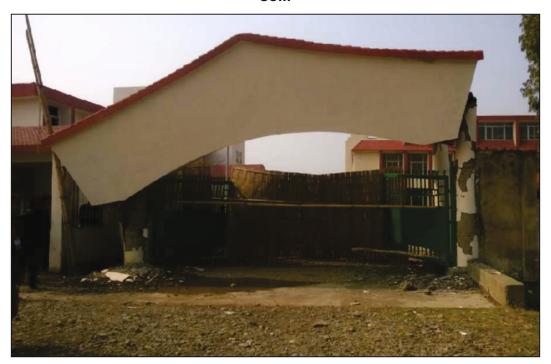
Figure 33: - Damaged Central Agricultural University gate due to landfill soil.

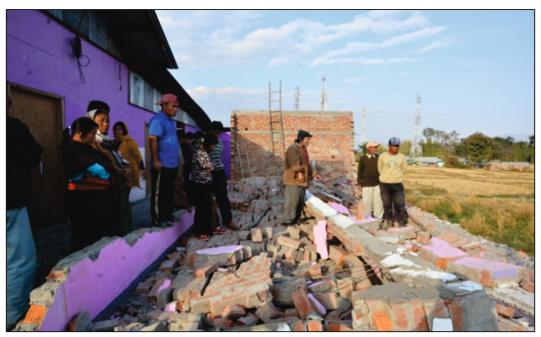
Figure 34: - Collapsed masonry building at Leimakhong area Manipur.

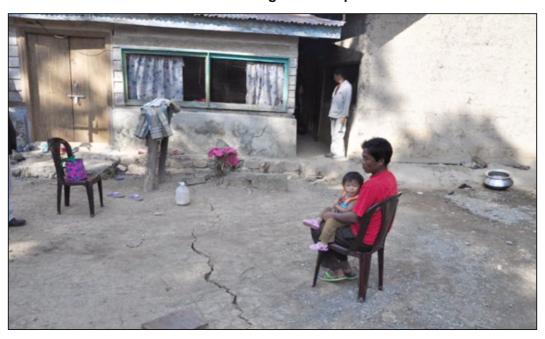
Figure 35: - Cracks observed in a masonry building with cement mortar bond at Leimakhongarea Manipur.

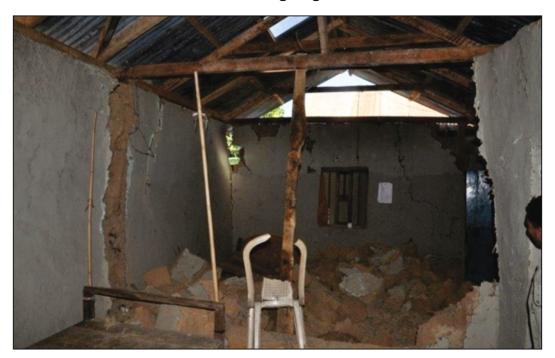
Figure 36: - Collapsed Mud wall house near the epicenter region Noney, Tamenglong.

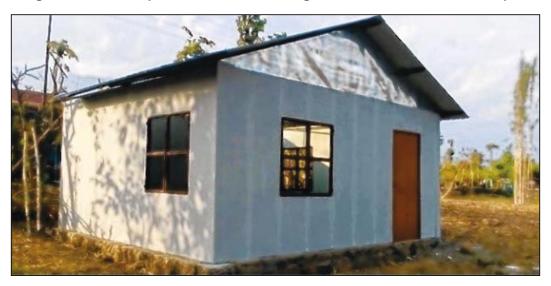
Figure 42: - Earthquake resistant housing models introduced in Senapati

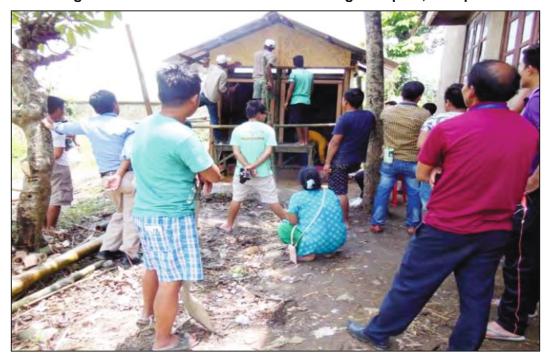
Figure 43: - Bamboo based Toilet Building at Imphal, Manipur.

First-time introduction of a bamboo toilet in Manipur and 5 days training at Mantripukhri forest complex, Imphal was conducted as part of relief operations by BMTPC. BMTPC is actively involved in developing and promoting bamboo-based technologies in the North-Eastern Region and other bamboo growing areas. Two types of bamboo toilets were constructed using local bamboo. The models were, single toilet for household usages and twin model for community usages like schools and other public places.

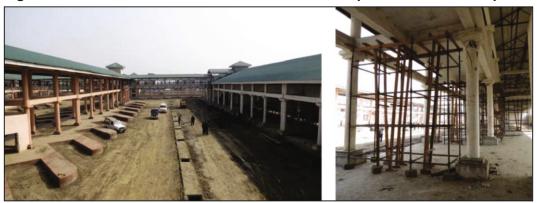
Figure 44: - A view of Inter-State Bus Terminal at Imphal after the earthquake.

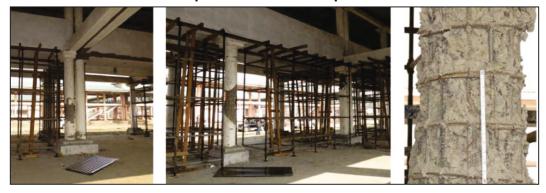
Figure 45 : - Severe damage to RC columns at the Inter-State Bus Terminal, Imphal after the earthquake

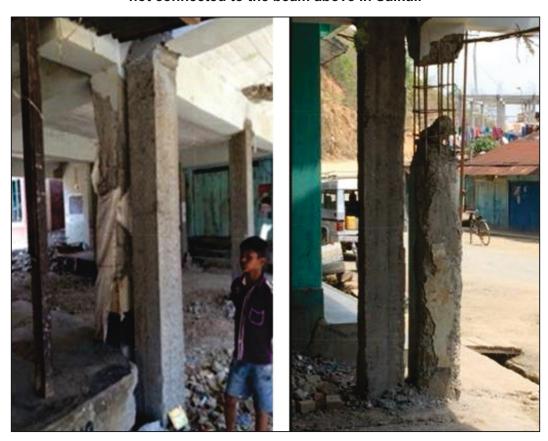
Figure 47: - Propping damaged RCC structures by newly constructed columns not connected to the beam above in Saikul.
