# Kinematic Analysis of Noklak Landslide, Tuensang District, Nagaland

Mademshila Jamir,\* C Nokendangba Chang,\*  
Temsulemba Walling\* and Keneiravinuo\*

*A very complex landslide has plagued Noklak town in the eastern part of Nagaland for more than two decades. The magnitude of the landslide has grown both in its influence and coverage area of 1.84 sq. km in last few years affecting the only route connecting the International Trade Centre at Pangsha (Dan), uprooting many households, cultivated areas and also posing a threat to nearly one-fifth of the town population presently. It is incorporated in SOI toposheet no. 83 N/4 and lies in 95°00'39" E longitudes and 26°11'52" N latitudes. The present study aims to identify the causative factors of this land instability by employing the method of kinematic analysis of the slope material to determine the potential mode of failure. These analyses were performed from 1,195 joint attitudes collected from in-situ rock exposures in the field to determine the dominant joints that control the instability in the area. The strength of the rocks was calculated by Point Load Test data on 50 rock samples. Both Rock Mass Rating (RMR) and PLT value

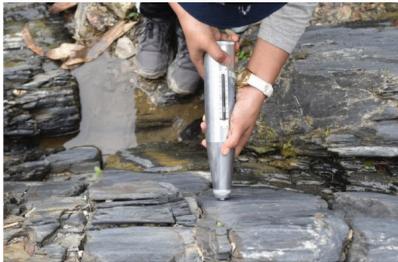
**Fig. 2: Schmidt Hammer**

In the case of the use of Schmidt hammer for determining the compressive strength of intact rocks, the UCS equation employed (Deere and Miller, 1966) is given as

Rebound number,  $R_n = 19.9$   
 Since the lithology in the study area is siltstone, density  $\rho = 2.6$   
 $UCS = 6.9 \times 10^{(0.16 + 0.0087 \times 19.9 \times 2.6)}$   
 $= 28.10$  MPa  
 RQD =  $115 - 3.3 \times 33 = 6.1$   
 $\alpha_j$  (joint direction) = 255,  $\alpha_s$  (slope direction) = 262  
 $\beta_j$  (joint angle) = 80,  $\beta_s$  (slope angle) = 37  
 Values are plotted in Table 7b

Rebound number,  $R_n = 28.84$   
 Since the lithology in the study area is shale, density  $\rho = 2.15$   
 $UCS = 6.9 \times 10^{(0.16 + 0.0087 \times 28.84 \times 2.15)}$   
 $= 33.79$  MPa  
 RQD =  $115 - 3.3 \times 38 = -10.4$   
 $\alpha_j$  (joint direction) = 175,  $\alpha_s$  (slope direction) = 120  
 $\beta_j$  (joint angle) = 85,  $\beta_s$  (slope angle) = 75  
 Values are plotted in Table 7b
