# Long Term Landslide Mitigation Technique Illustrated- A Case Study

*Landslide is the mass movement comprising of rock, debris or soil under gravity influence. The main slide triggering factors are rain and tectonic seismicity induced landslides occurring in the Himalayan belt of the Indian subcontinent. Anthropogenic activities like tunnel blasting for hydroelectric projects, unplanned excavations or cuttings of the side for road widening purpose activates failure mechanism. On the other hand, continuous blasting and tunnelling weaken the rock joint layers. Based severity of rock joints and rock surface conditions; rock structures have been characterised into different range of GSI chart. Thorough study and analysis are required to check the long term stability for these type of weak slopes with GSI range of 10 to 40 having fair, poor to very poor surface conditions lying close to important and sensitive structures. The present study reveals the effectiveness of preventive measure applied to the unstable slope stretch in the vicinity of Teesta stage III hydroelectric system. Finite element modelling has been carried out for the critical slide triggering stretch using Rocscience-

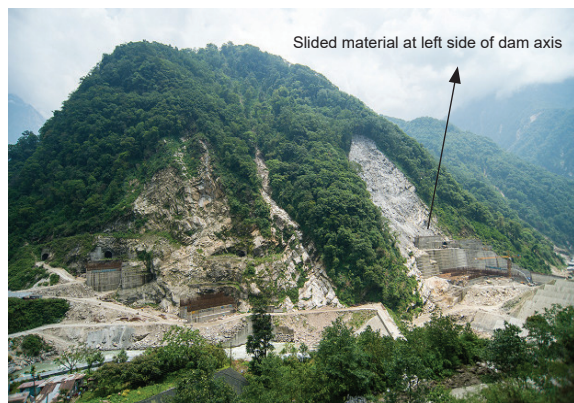
**Fig. 5.4: Protection works for unstable portion**

The unstable portion was observed during construction activities at the dam site and cutting of left abutment which was susceptible to failure. GSI of 25 shows the rock structure of disintegrated- poorly interlocked, heavily broken rock mass with a mixture of angular and rounded rock pieces. This value of GSI suggests a weak rock condition.

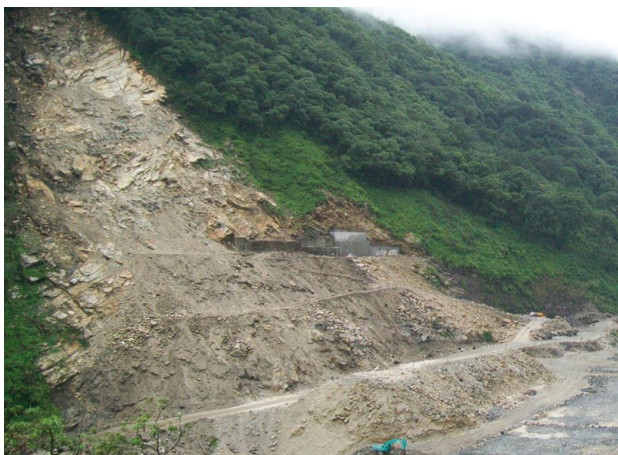
**Fig. 5.5: Site condition before the start of work**

Landslide issue was observed due to excessive stripping and cutting of the left abutment as shown in Fig. 5.5. About 1 lac m<sup>3</sup> debris slide down the hill after the cutting work at the left abutment of the dam site.

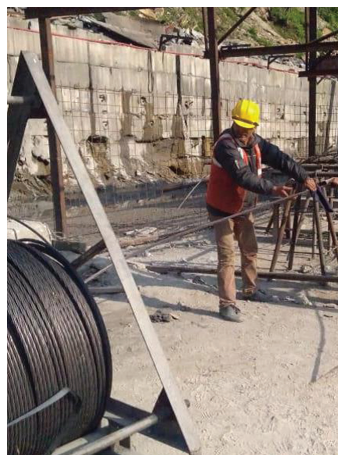
**Fig. 5.6: Before commencement of cable anchoring**

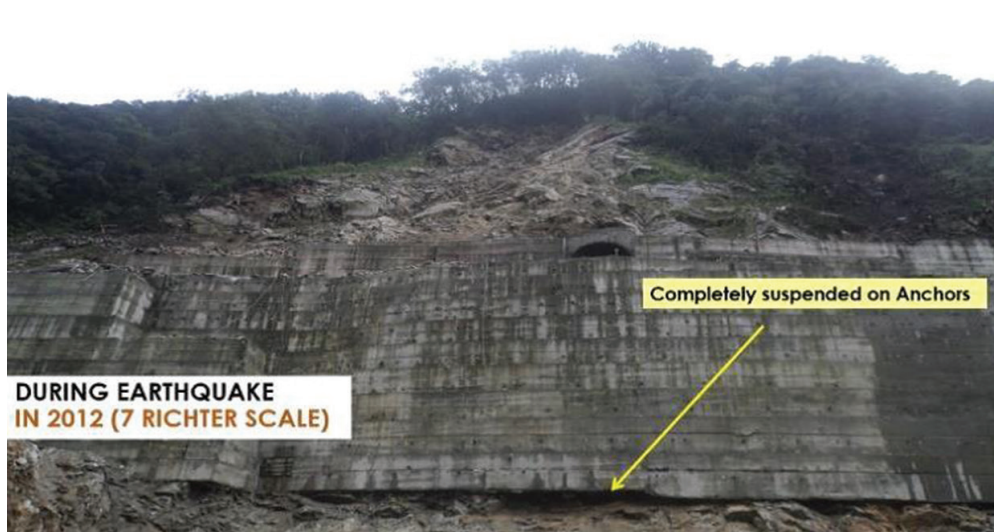
**Fig. 5.17: Condition of stabilised slope with prestressed cable anchor after 2012, earthquake (Magnitude 7)**

The present analysis shows that there is a significant improvement in the safety factor results. The current status of the project site is that the 50 m vertical cladding wall having prestressed cable anchor with no base support survived the 2012 earthquake of 7 Richter magnitude scale with no signs of distress.
